Manhole Inspection Summary

Manhole # S25AA1017MH

Insp Date: **1/29/07 10:49 AM**

Location Address: **1201 36TH ST**

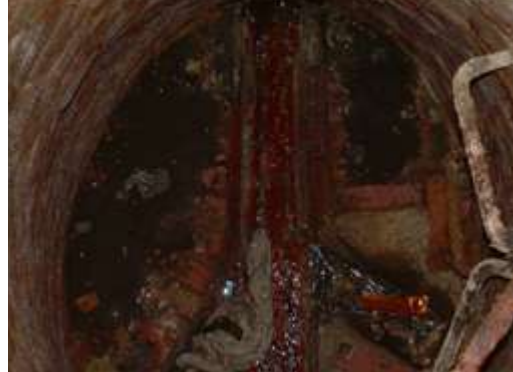
Top View

Condition: ☐ Sound ☐ Cracked ☐ Root Intrusion ☐ Deteriorated ☐ Leaks ☒ **Debris**

Count: **5** Missing: **0** ☒ **Corroded**

Corroded steps. Bench and Channel debris.

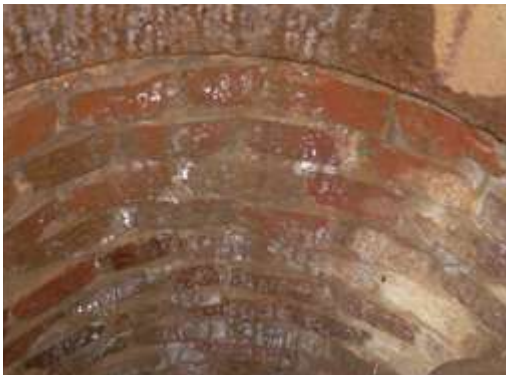
Defect

Condition: ☐ Sound ☐ Cracked ☐ Root Intrusion ☐ Loose Brick ☒ **Deteriorated**

Infiltration: ☐ None ☒ **Joint** ☐ Cracks ☒ **Mortar** ☐ Roots ☐ Wall

Adjustment deterioration and infiltration.

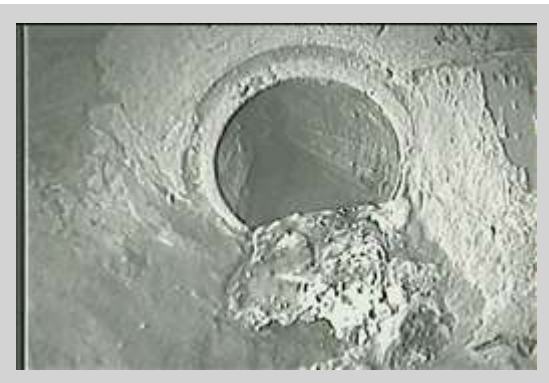
6 in. Circular Gravity Sewer Pipe In @ 4 O'Clock

Deposits: ☐ None ☐ Mud ☐ Sludge ☒ Debris ☒ Grease

Silt Depth: **1** (in.) Deposits Extent: **Light**

Infiltration: **Evidence** Pipe Seal Cond: **Unknown**

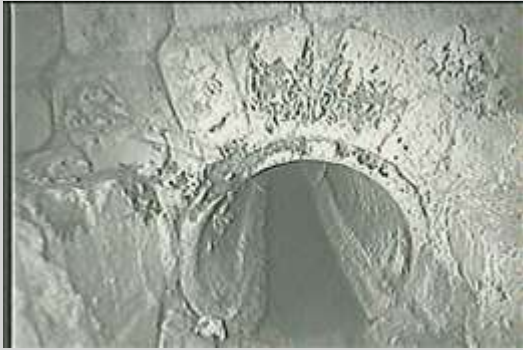
8 in. Circular Gravity Sewer

Deposits: ☐ None ☐ Mud ☐ Sludge ☐ Debris ☒ Grease

Silt Depth: **0** (in.) Deposits Extent: **Light**

Infiltration: **Evidence** Pipe Seal Cond: **Unknown**
